## Post Fire Assessment of RCC Buildings Through Rapid Visual Screening

Chopasani Housing Boards building in Jodhpur, Rajasthan, India, the utility of RVS is further exemplified in evaluating the impact of fire on RCC columns, beams, and stairs, thereby highlighting its importance in post-fire structural assessments.

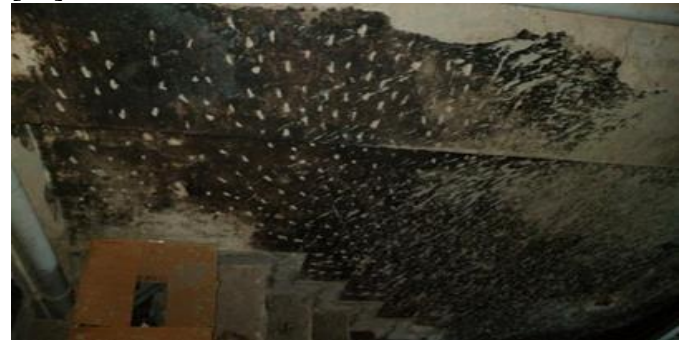
Following a fire at a bakery shop located within a housing board building, smoke from the flames penetrated various sections of the structure, resulting in damage to the occupied areas due to soot deposition. While there was no significant damage but layers of plaster and concrete were significantly

impacted by the soot deposition. According to the RVS (Rapid Visual Screening) process, the building incurred losses estimated to be between 20% to 30%. Upon thorough inspection, it was determined that each column and beam [16] of the structure fell under the category of figure 1 mild damage. Subsequently, retrofitting efforts were undertaken, primarily focusing on maintenance requirements [17].

**Figure 1 Soot Deposition in Building**

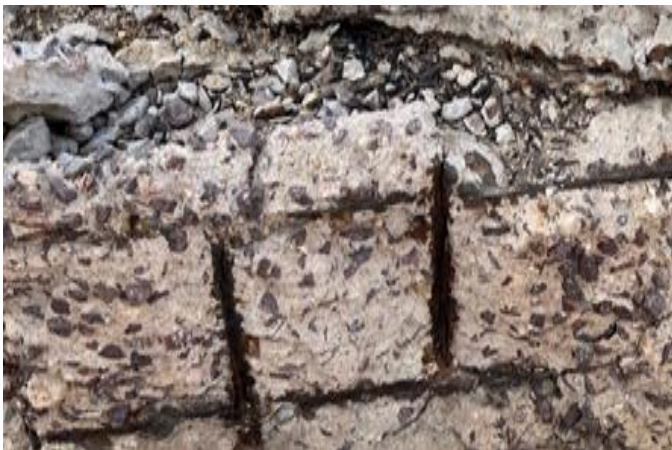
After the building fire, the steel reinforcement became visible through the concrete, prompting a laboratory assessment of the affected properties. It was observed that the fire had led to alterations in key [19] characteristics such as yield strength and corrosion resistance, resulting in a decrease in steel durability. Additionally, the threads of the steel were damaged, weakening the bond between the concrete and steel figure 3. Furthermore, other characteristics, such as the Young's modulus, were evaluated by analyzing stress-strain curves up to the proportional limit. Approximately 50% of the steel in the building was lost, with the loss assessed approximately in the structure.

**Figure 3 Shows the Reinforcement Visible in the Stair After the Concrete Fire**

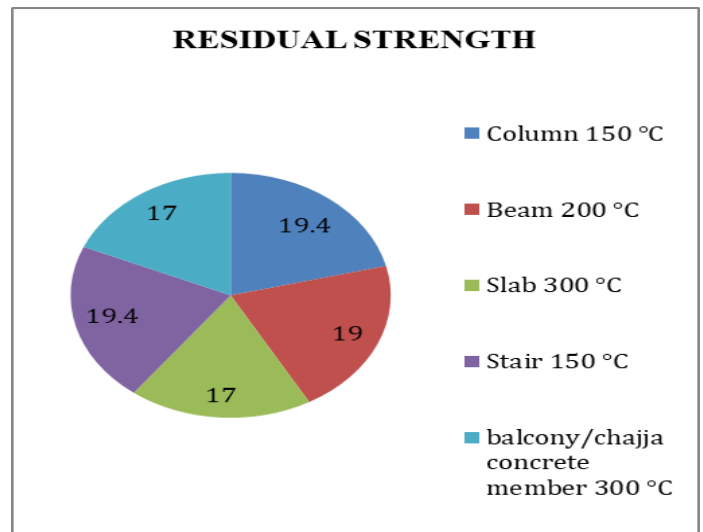
**Figure 5 Illustrates the Residual Strength of Each Element at Specific Temperatures**

The graph below illustrates the temperature of each element at specific times, as determined by the application of the Euro code 2. The reduction factor is used figure 5 to evaluate the strength of individual elements, revealing their residual strength following post-firing assessment [26].
